**INTERIM FIELD PROCEDURE FOR BOMB
DAMAGE REPAIR - USING CRUSHED ^{LINE} STONE FOR
CRATER REPAIRS AND SILIKAL® FOR SPALL REPAIRS**

MICHAEL T. McNERNEY
ENGINEERING DIVISION,
RAPID RUNWAY REPAIR SECTION

APRIL 1979

INTERIM REPORT
JUNE 1978 - MARCH 1979

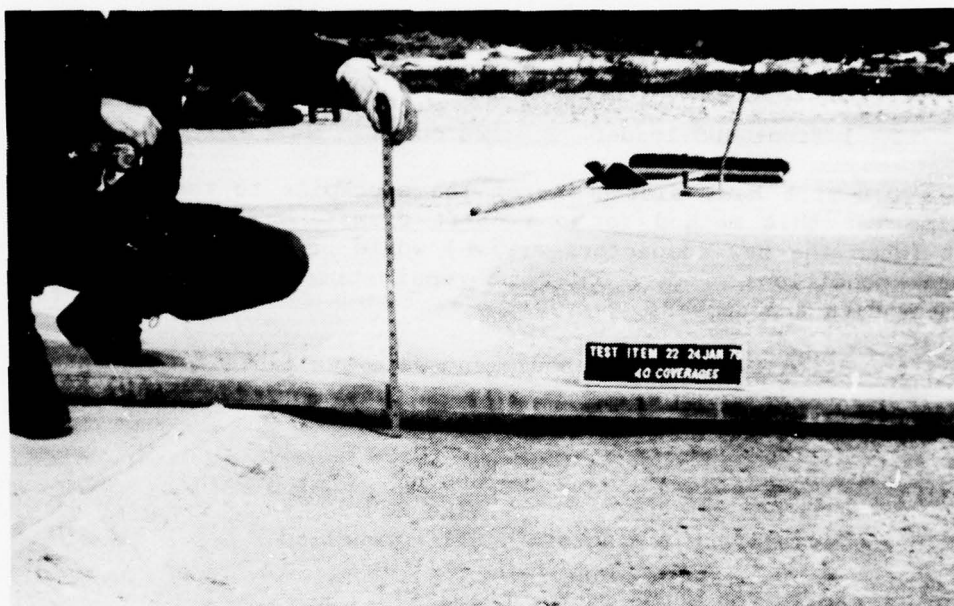
Figure 6
Consolidation of Crushed Stone at Edge of Concrete

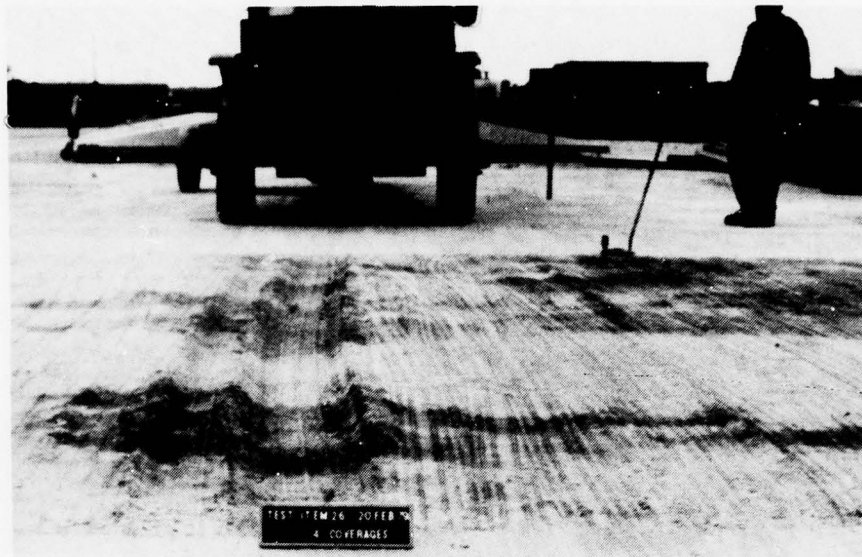
Figure 18
Typical Initial Rutting on Satisfactory Repairs

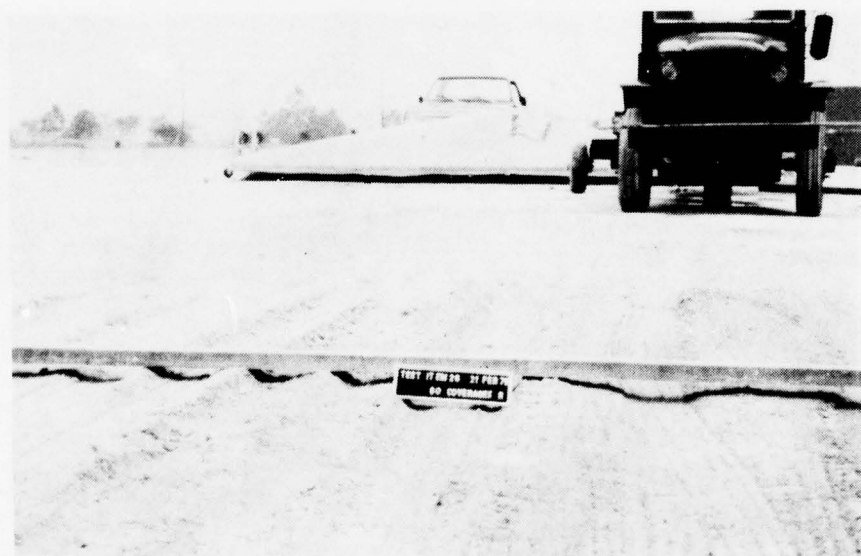
Figure 19
Typical Rutting After 60 Coverages (576 Passes)

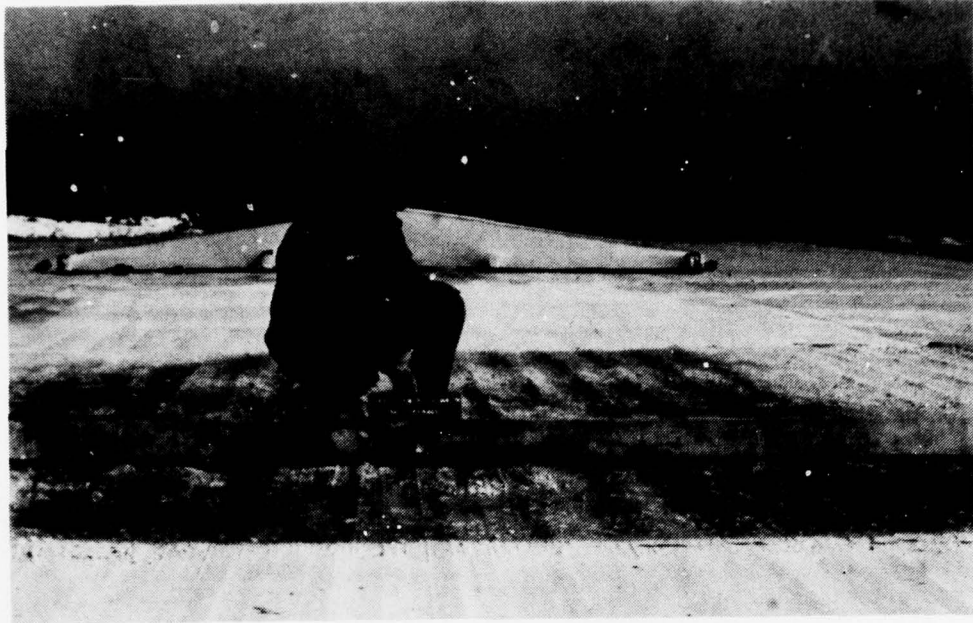
Figure 20
Typical Rutting After 150 Coverages (1440 Passes)

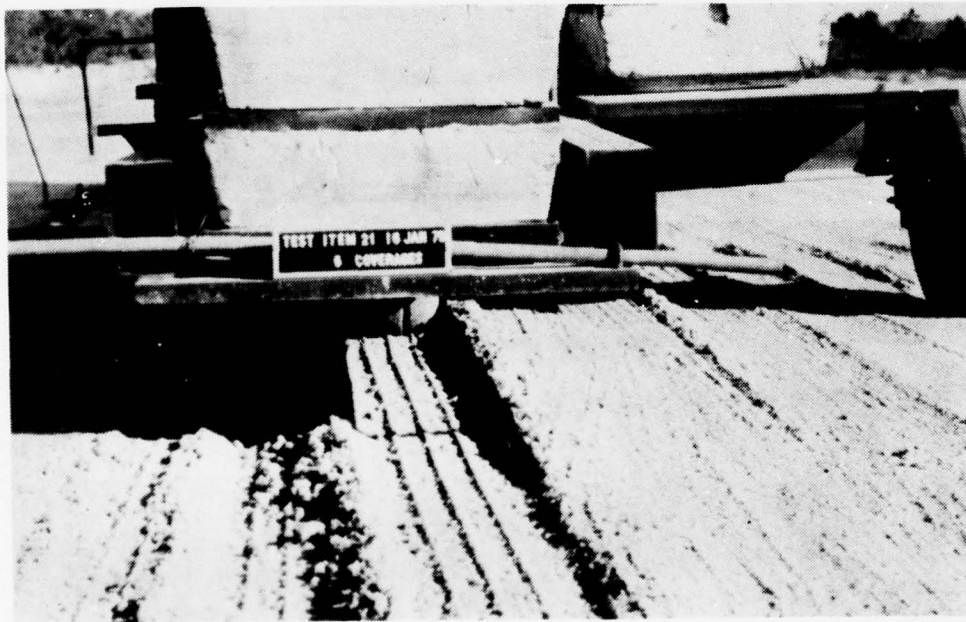
Figure 21
Actual Failure Due to Rutting

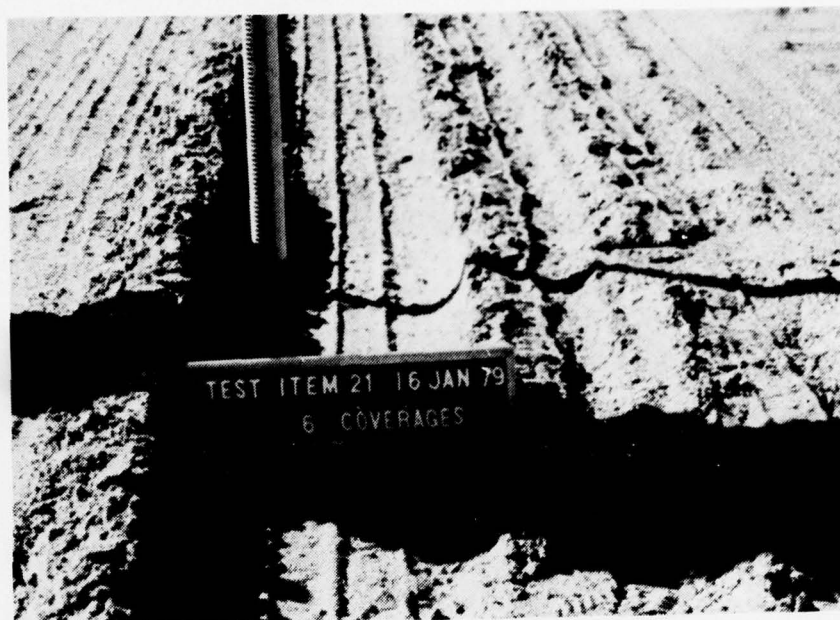
Figure 22
Actual Failure Due to Rutting

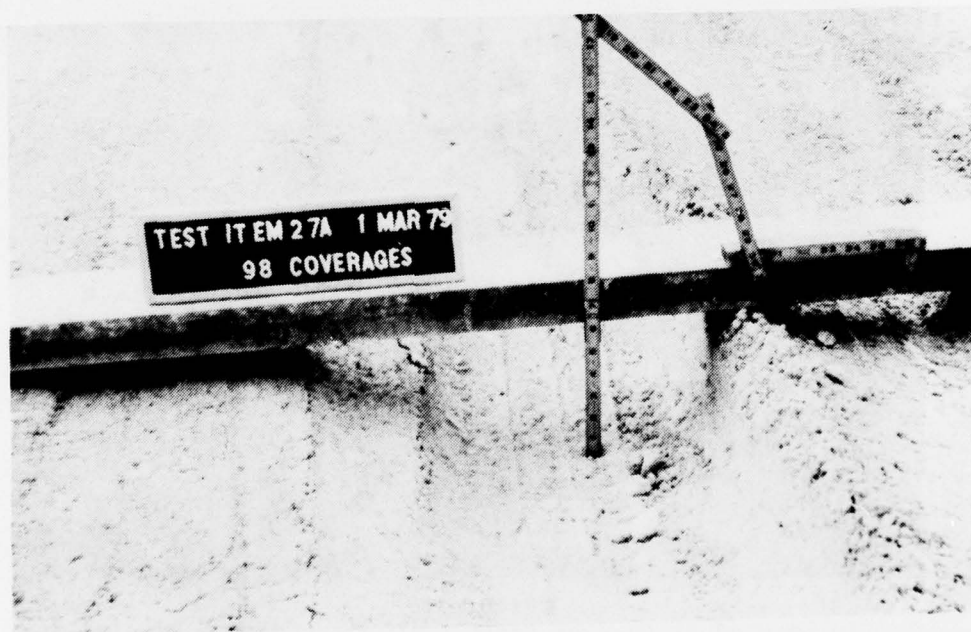
Figure 23
Actual Failure Due to Rutting

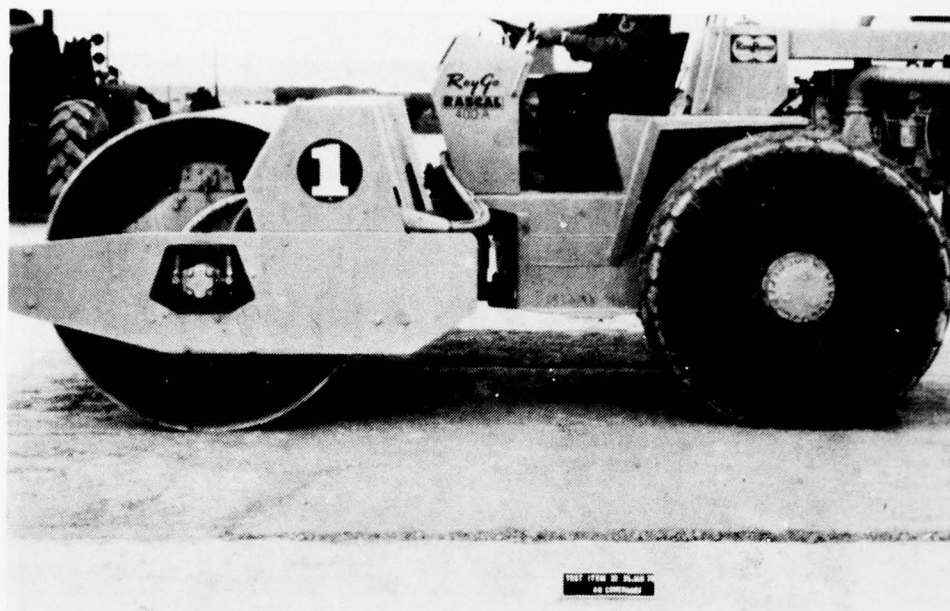
Figure 24
Repairing Patch by Adding More Material and Recompacting

If repairs are required due to rutting or consolidation of the crushed limestone, they should be made in much the same manner as the original repair. If high water content is a problem, it will be necessary to remove some surface material with a front end loader or dozer. If moisture is not a problem just add new material directly to the repaired crater and compact with the vibratory compactor for 24-32 coverages. When possible it is highly advisable to scarify the old limestone surface before adding new material. This will aid in preventing the new lift of crushed limestone from separating into layers and peeling off.

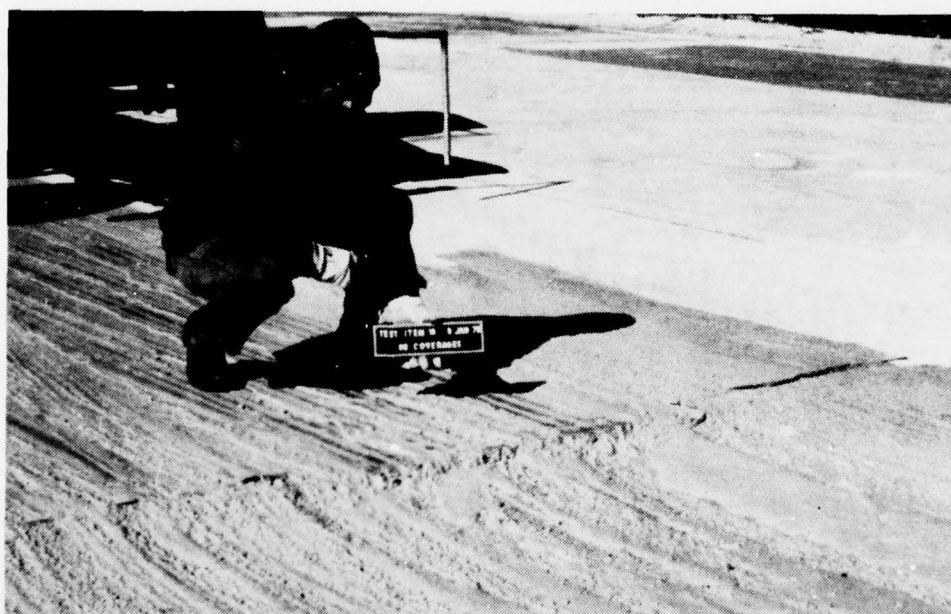
Figure 25
Lip Created at Edge of Patch by Movement of Crushed Stone

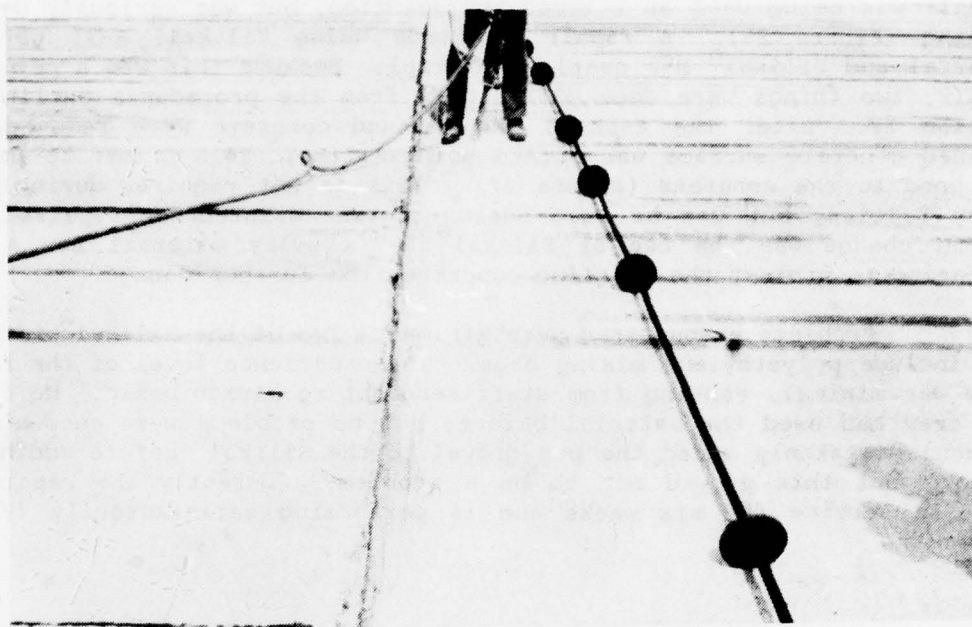
The first repair was to the runway beneath the arresting cable. This particular area is where the BAK-12 arresting cable impacts the runway during every aircraft pass, wearing away the concrete. A cold mix

asphalt was being used as a temporary solution, but was seriously deteriorating (Figure 26). A repair was made using Silikal® R-17 patching material and Silikal® R-7 overlay material. Because this was a permanent repair, two things were done differently from the procedures outlined in Section IV. After the asphalt and unsound concrete were removed, the cleaned concrete surface was primed using Silikal® R41S primer to improve the bond to the concrete (Figure 27). This is not required during emergency repairs, but can be used during routine maintenance repairs. The second change was the use of Silikal® R-7 overlay material for a thin surfacing to protect the existing concrete from further damage.

Figure 26
Spalling Under BAK-12 Arresting Barrier Cable

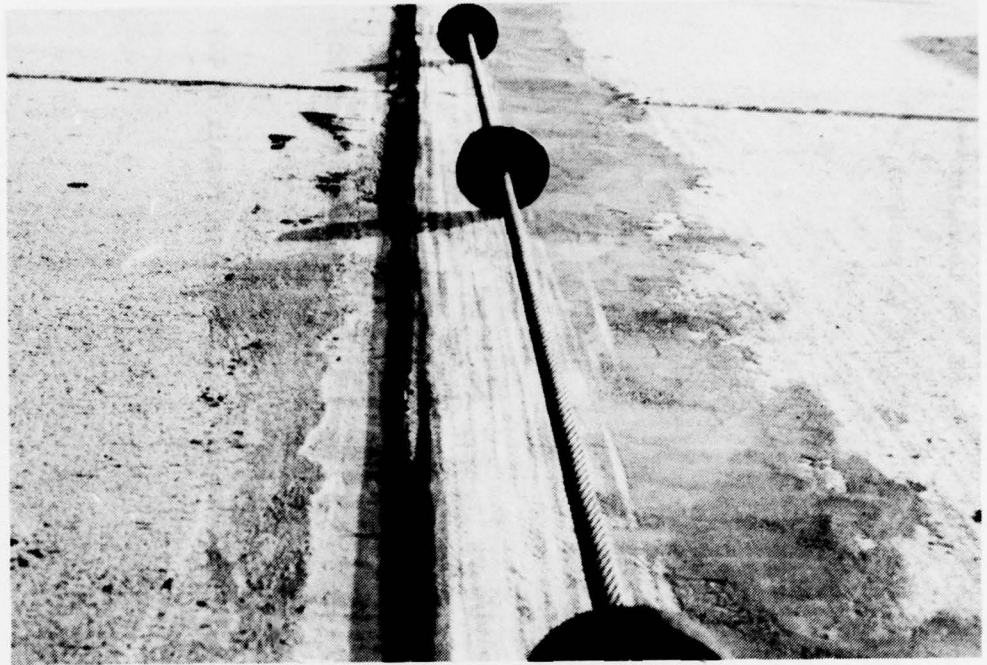
Problems encountered were minimal. Two of the Silikal® kits did not include polyethylene mixing bags. The experience level of the repair crew was minimal, ranking from staff sergeant to airman basic. No one in the crew had used the material before, but no problems were encountered. Someone mistakenly added the pea gravel to the Silikal® before adding the liquid, but this proved not to be a problem. Currently the repair has been in service for six weeks and is performing satisfactorily (Figure 28).

Figure 28
Silikal^R Repair After Three Weeks of Service Under Arresting
Barrier Cable

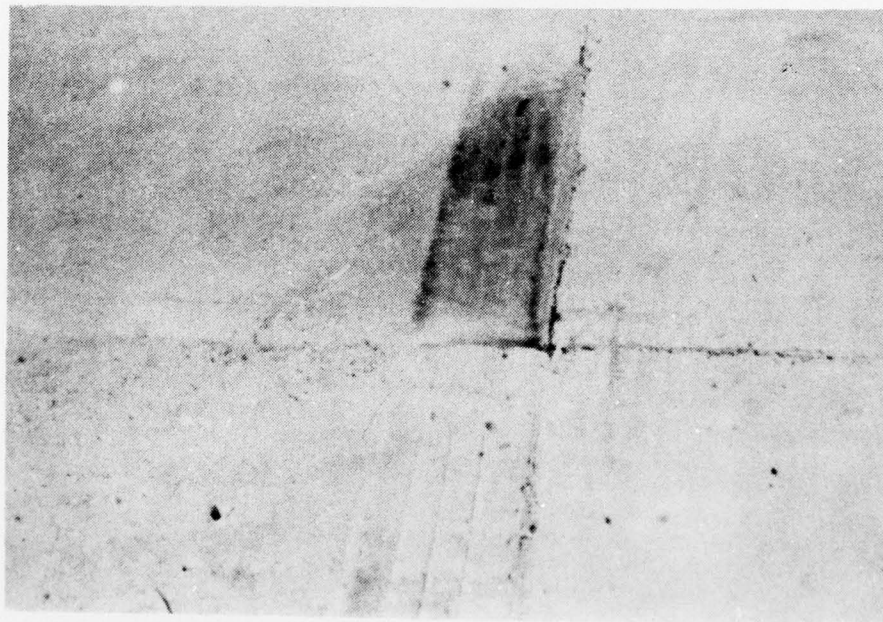
Figure 31
Spall Repair After 20 Passes of F-4 Loadcart Showing
No Damage
